Moa Pt WWTP

Damage Assessment Report – Stage 2

Prepared for s7(2)(a) – Privacy
Prepared by Beca Limited

17 April 2026

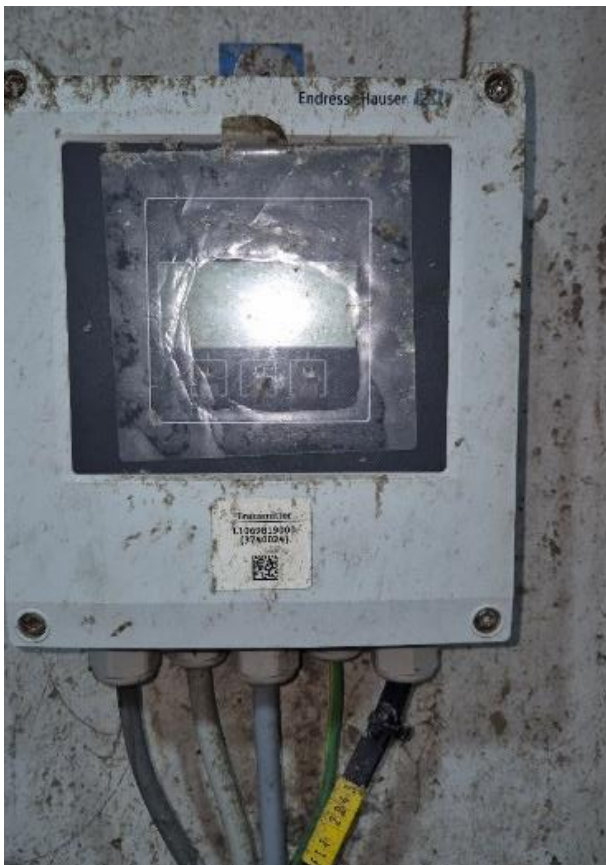
Figure 26: Primary sludge flow transmitter (L) and PLC remote IO cabinet and power supply for flow meter (R)

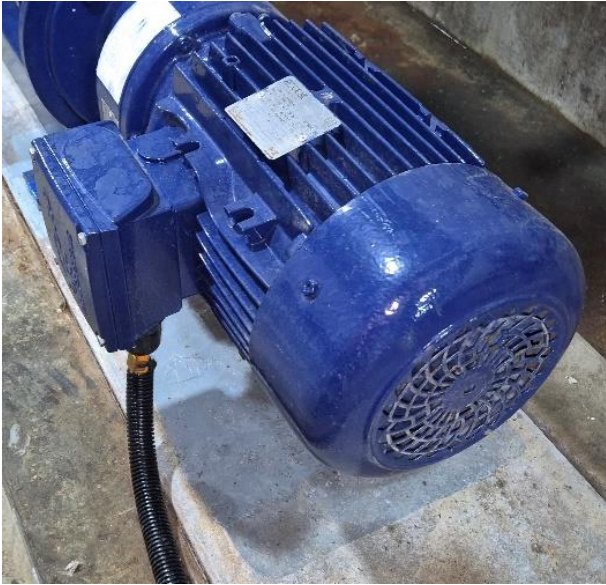
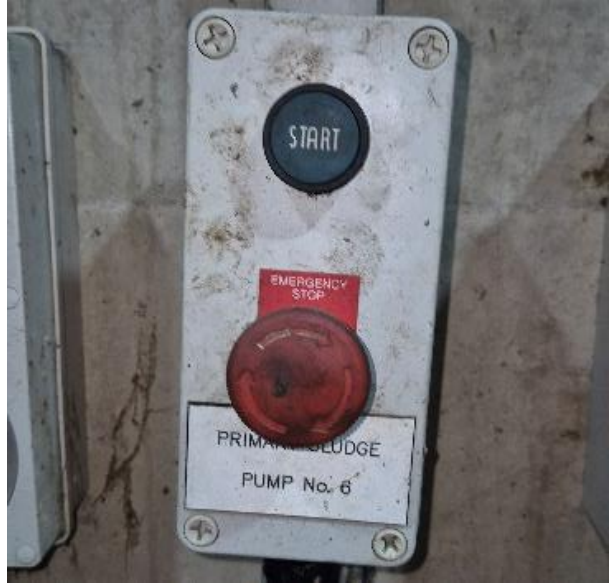
Figure 28: Primary Sludge Pump motor (L) and local control station (R)

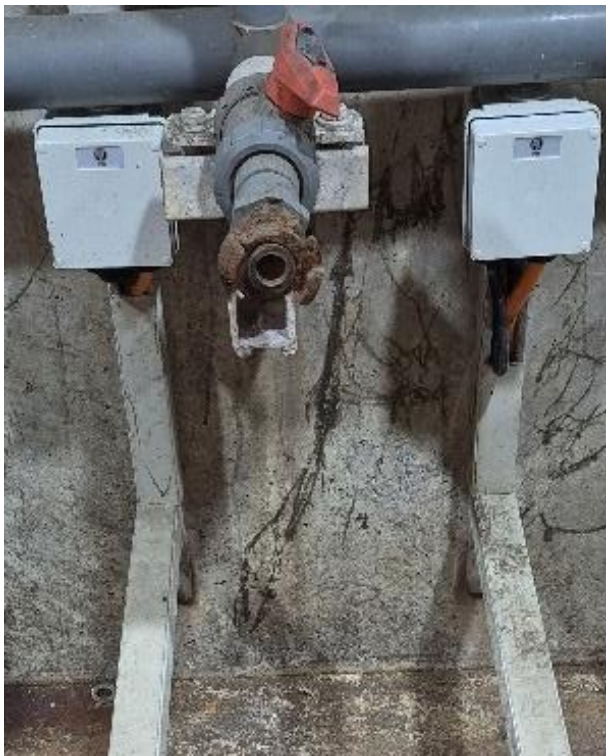
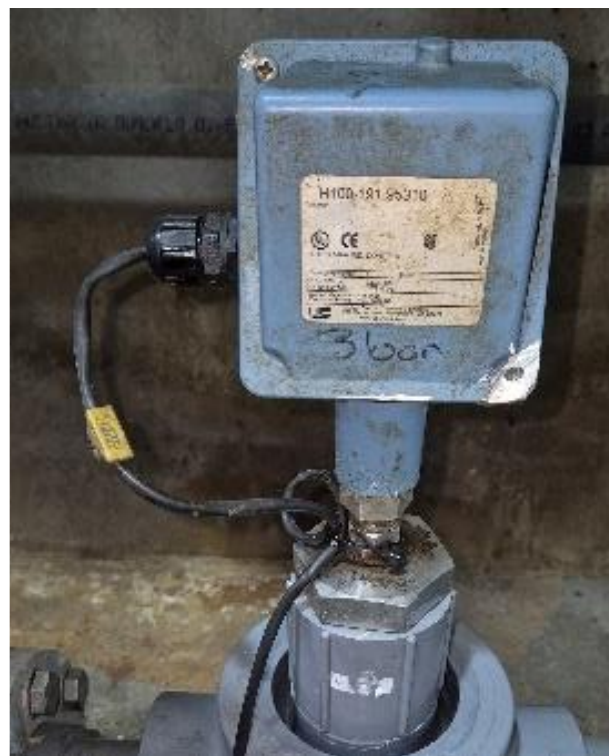
Figure 29: Primary sludge pump termination boxes (L). Pressure switches (R)

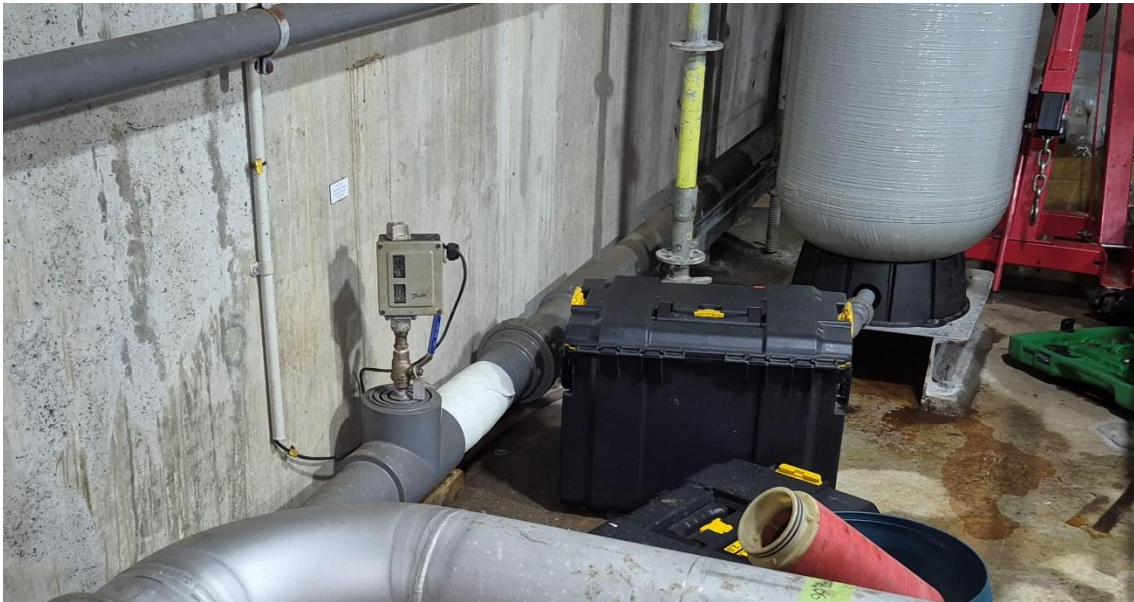
The RE pressure switch on the mezzanine floor was fully submerged. The Danfoss pressure switch was not rated for submergence so likely non-functional.

Figure 32: RE Pressure switch

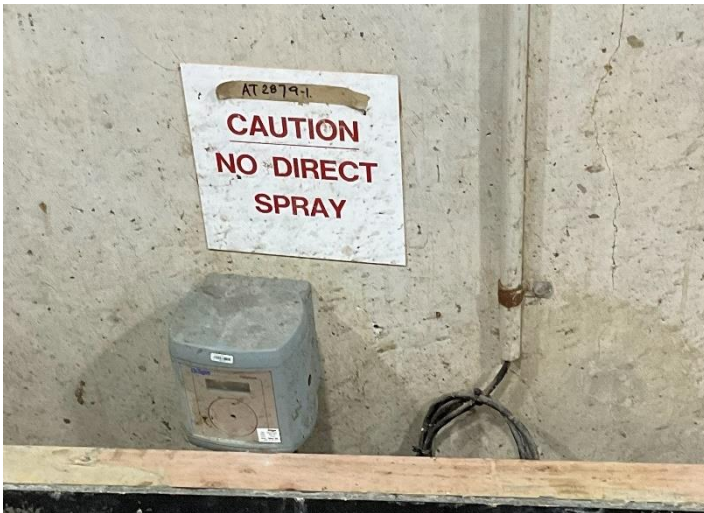
All Draeger H2S sensors at ground level were fully submerged and open to atmosphere.

Figure 36: Draeger H2S sensor

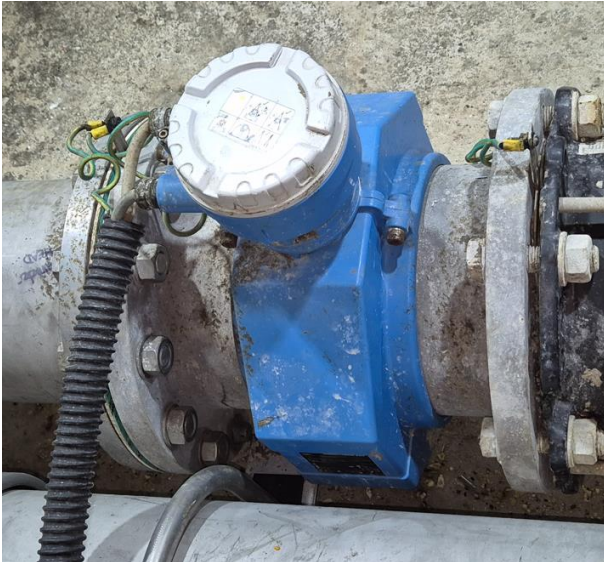
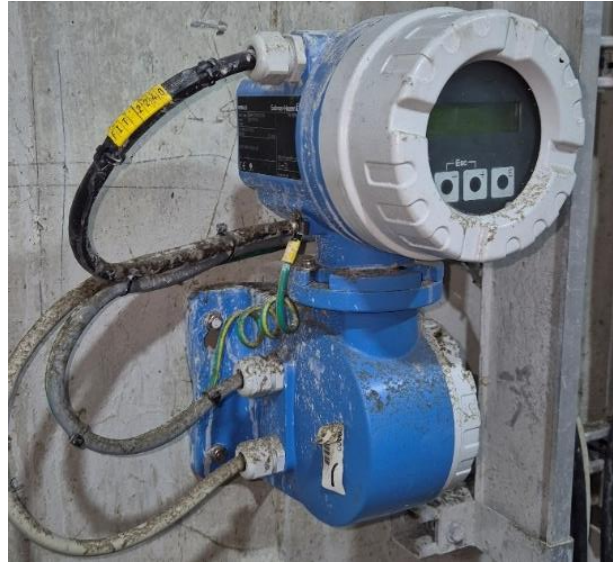
Endress+Hauser Promag flow meter and transmitter were fully submerged. Both are rated IP67. The flow transmitter is wired to the local sludge gallery remote IO panel for both signal and power. The panel was fully submerged (see above).

Figure 37: Flow meter (L) and transmitter (R)

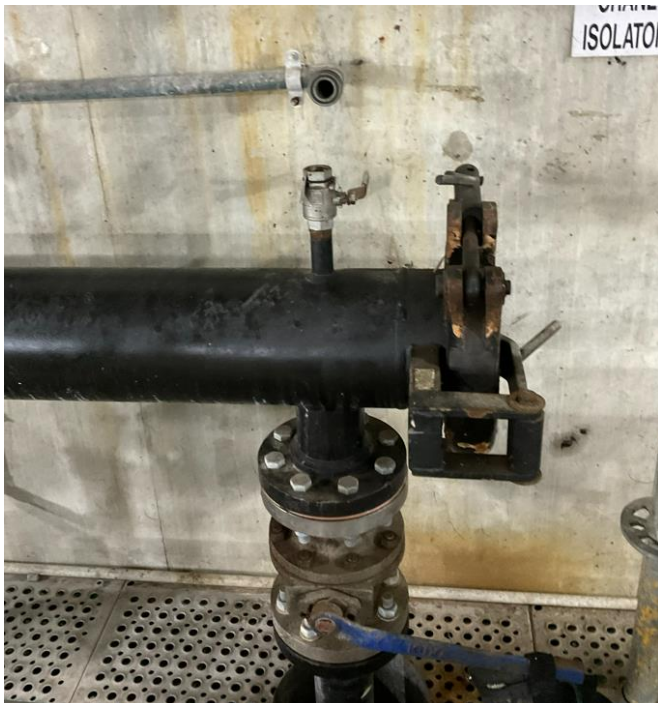
Figure 46: Sludge transport pig launcher arrangement

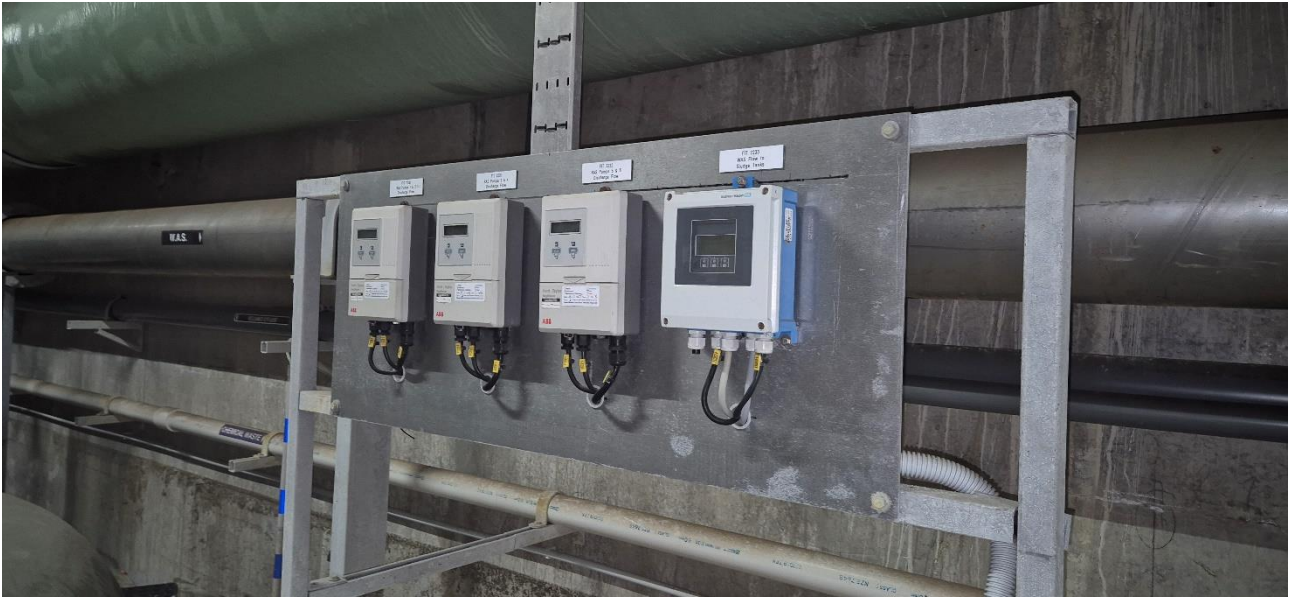
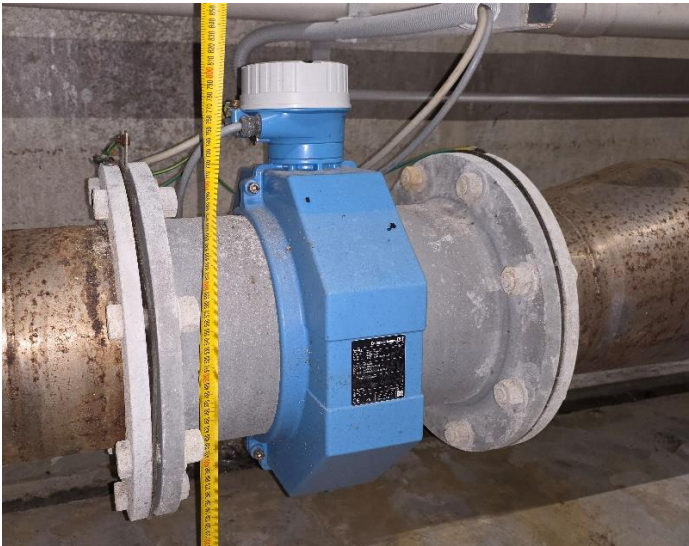
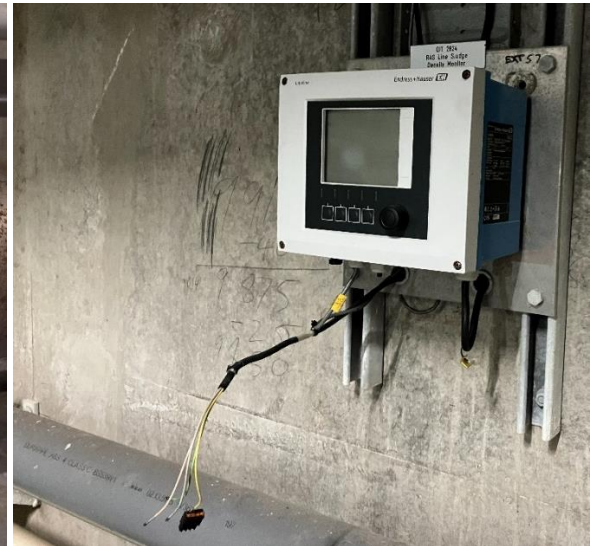
The sludge density indicator/transmitter AIT-2824 was observed to be not fully commissioned at the time of inspection and is understood to be a recent installation. Loose cabling was observed. The operational status and flood exposure condition could not be confirmed based on observation alone.

Figure 55: Top: 3x RAS and 1x WAS Flow Transmitters on Panel, Bottom Left: WAS flowmeter, Bottom Right: RAS Sludge Density Transmitter (not in service).

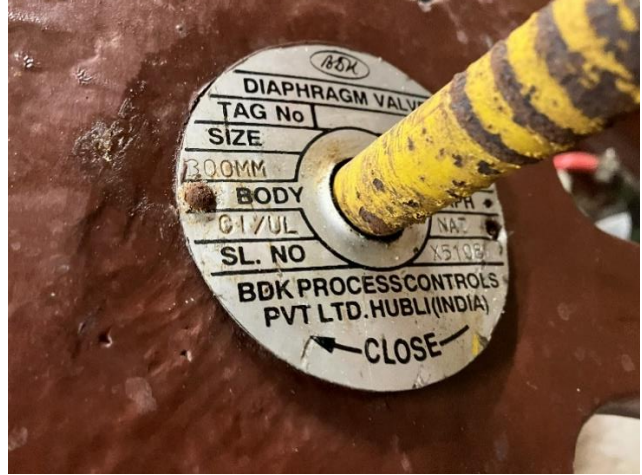
Figure 57: WAS pipework in service gallery

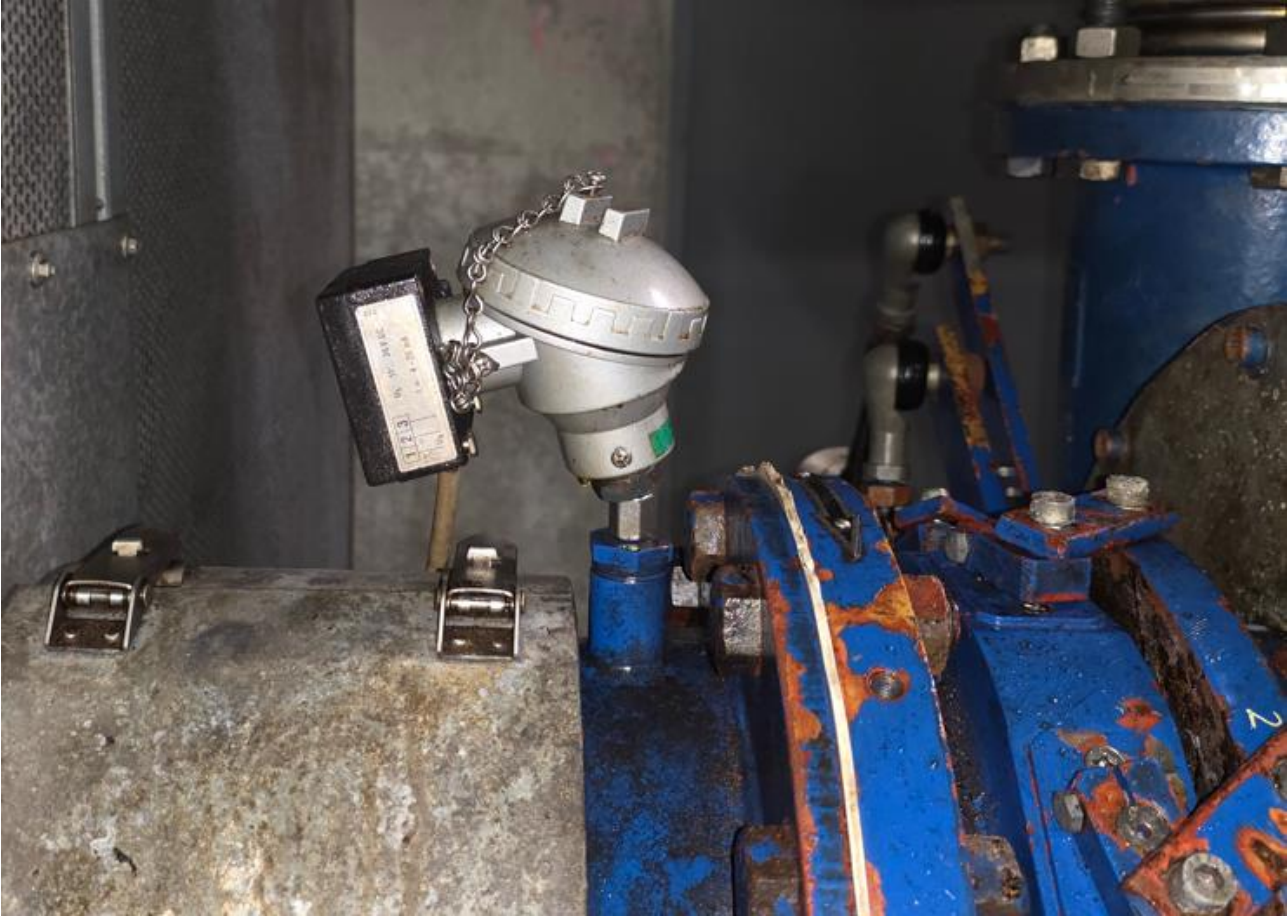
- Installed at a similar elevation to PIT-2325 and assessed as being well above the flood water level. Direct flood exposure is not indicated.

Figure 67: Blower instruments

Figure 68: Blower instruments

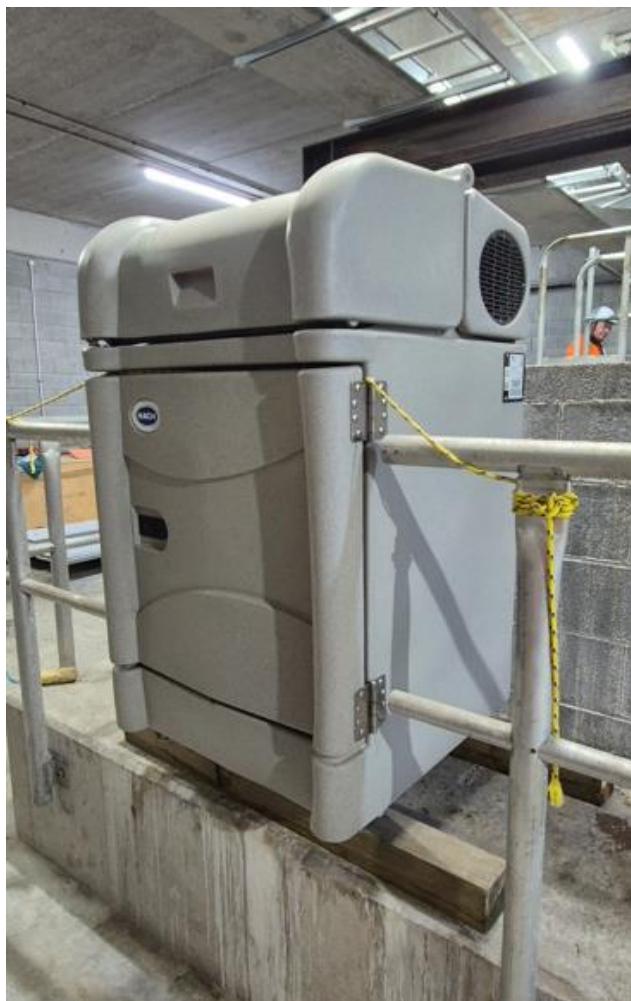
Asset E-00297848 could not be located at the time of inspection and was therefore not assessed. Its exposure condition and operational status could not be confirmed.

Figure 91: UV Auto Sampler
